Inspection Report

Happy Client

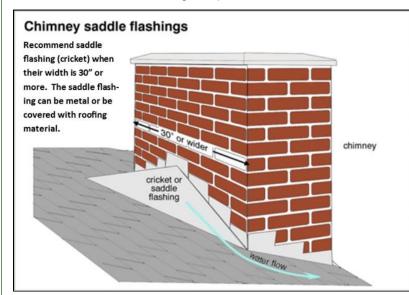
Typical for assumed age of structure- Chimney cricket(s) not present (a cricket, also referred to as a saddle, is a peaked, structural piece used to divert water and debris from around a chimney recommended when the chimney width is more than 30 inches). A chimney cricket would be desirable for this chimney. Recommend a qualified licensed roofing contractor install proper cricket/saddle as needed. In the event that a cricket/saddle is not installed inspector at the least recommends monitoring and maintenance be performed to prevent leaks, and install when roof covering is replaced.

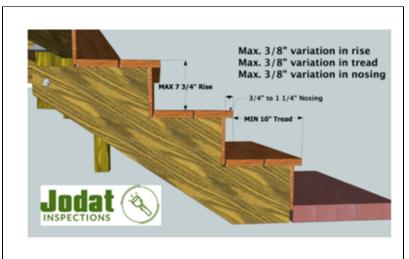
and any other problems that a qualified specialist contractor may discover while inspecting further and performing repairs need correcting to ensure steps, stairs, porches and railings are proper. Do not rely on pictures alone. Pictures are examples only. One or more could cause a fall and or injury at a minimum, be aware of these hazards.

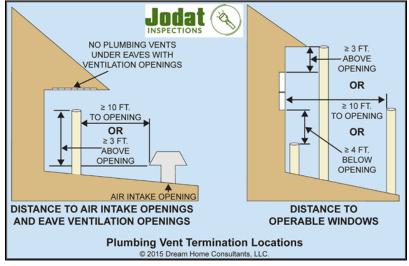
and any other problems that a qualified licensed plumbing contractor may discover while evaluating further and performing repairs needs correcting. Plumbing venting issues can be a potential cause of poor plumbing performance and/or health concerns. Do not rely on pictures alone. Pictures are examples only.

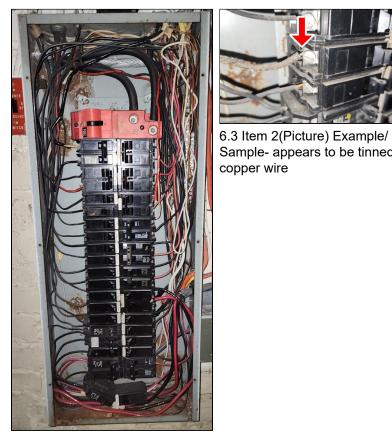
or concerns may exist). Electrical issues are considered a safety hazard until repaired. Do not rely on pictures alone. Pictures are examples only.

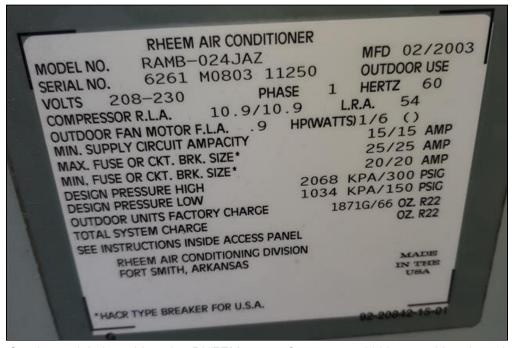
Condenser label outside unit – RHEEM – manufacture year 2003 – considered aged – size 2 ton

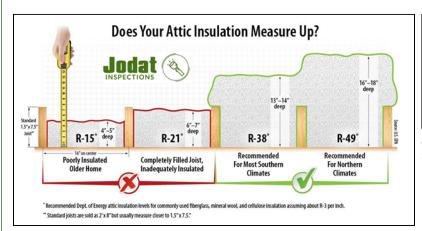
and any other problems that a qualified contractor may discover while evaluating further and performing repairs need correcting ensure areas are properly insulated to ensure a unreasonable amount of conditioned air loss does not occur, and lack of insulation can cause condensation for example. Do not rely on pictures alone. Pictures are examples only.
