Inspection Report

Property Address:
1234 Street
Virginia Beach Virginia 22222

JODAT INSPECTIONS

Date: 8/26/2017	Time:	Report ID:
Property: 1234 Street Virginia Beach Virginia 22222	Customer: Happy Client	Real Estate Professional: Happy Agent

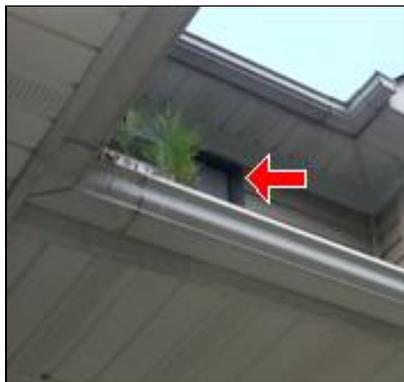
1.2 Item 1(Picture) Front of home-

(2) Gutters are full of debris and or water in one or more areas and needs to be cleaned (*debris in gutters can also conceal rust, deterioration or leaks that are not visible until cleaned, and I am unable to determine if such conditions exist*). Recommend correction by a **qualified person** as needed.

(2) Gutters **are full of debris and or water in one or more areas** and needs to be cleaned (*debris in gutters can also conceal rust, deterioration or leaks that are not visible until cleaned, and I am unable to determine if such conditions exist*). Recommend correction by a **qualified person** as needed.

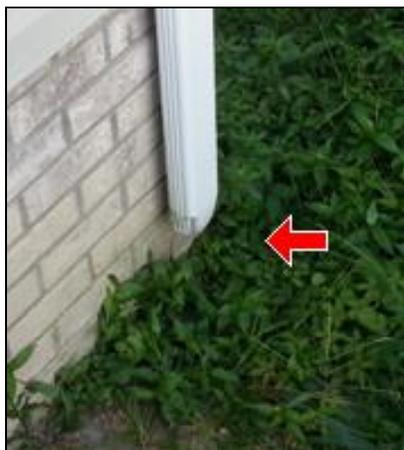
1.2 Item 2(Picture) Rear of home-

(4) One or more downspouts are damaged, and or missing components. Recommend correction by a qualified person as needed.

(4) One or more downspouts are damaged, and or missing components. Recommend correction by a qualified person as needed.

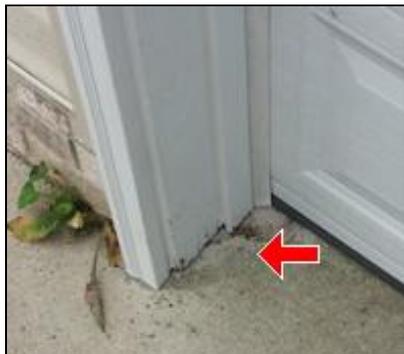
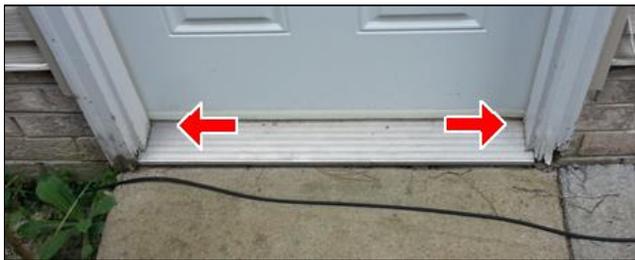
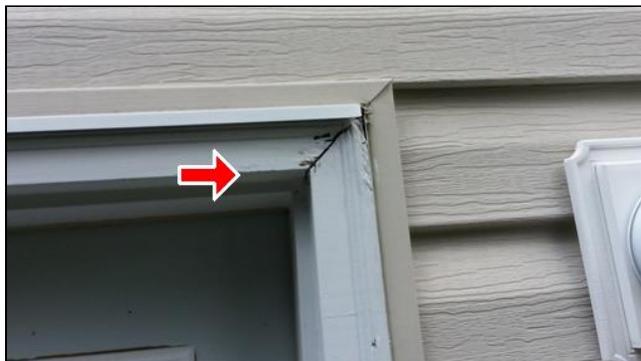
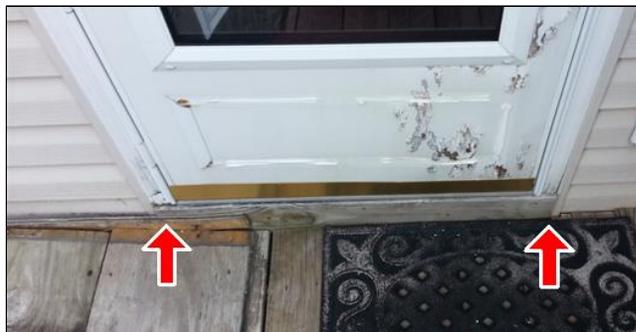
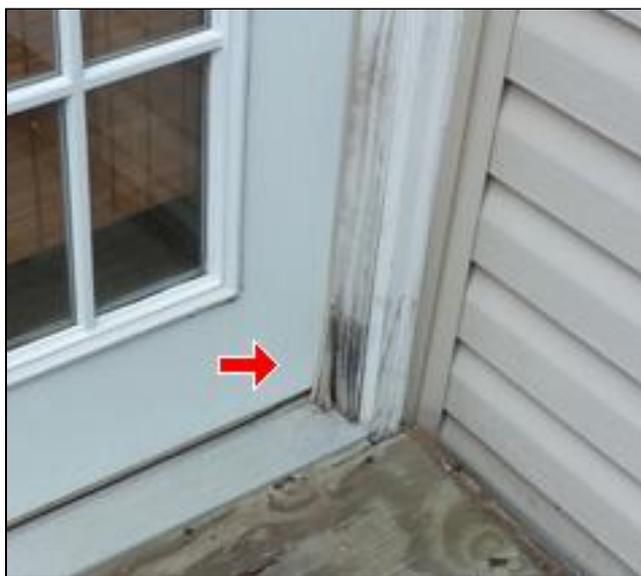
(1) **Exterior in areas-** One or more wood components on exterior were or appear to be deteriorated, loose, split, warped, missing, damaged, and or substandard in areas. Further deterioration can occur. Recommend further evaluation/inspection and correction of wood components by a qualified licensed contractor as needed

(1) **Exterior in areas-** One or more wood components on exterior were or appear to be deteriorated, loose, split, warped, missing, damaged, and or substandard in areas. Further deterioration can occur. Recommend further evaluation/inspection and correction of wood components by a qualified licensed contractor as needed

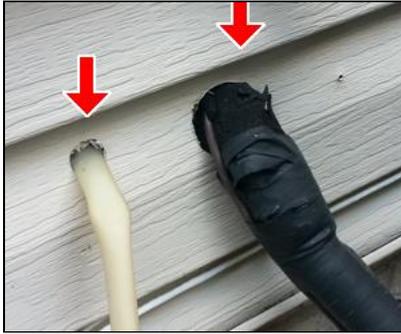
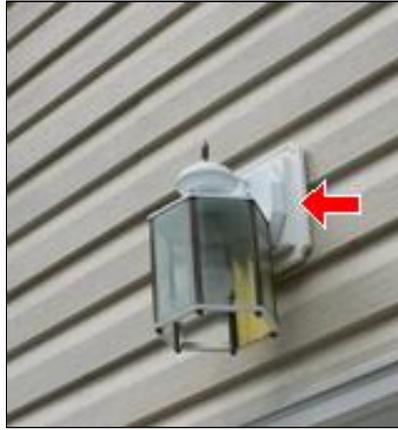
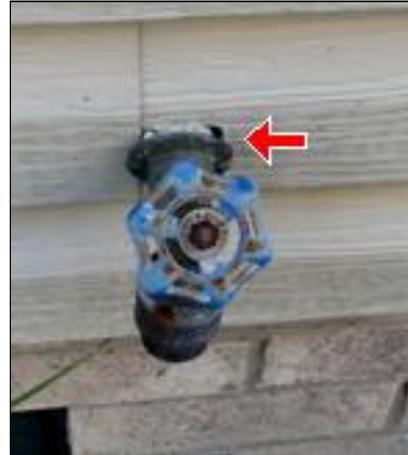
(2) **Exterior in areas-** There was needed sealant/caulk maintenance at areas around home. Recommend that a qualified person renew or install caulk as necessary around windows, doors, siding butt joints, siding-trim junctions, and wall penetrations. Where gaps are wider than 1/4 inch, an appropriate material other than caulk should be used. For more information, visit: http://www.reporhost.com/_docs/FPL_Caulking_Ins_Outs.pdf

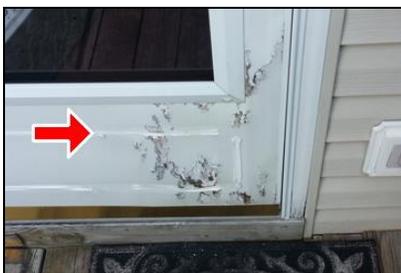
2.2 Item 1(Picture)

Rear entry storm door is damaged. Recommend correction by a **qualified person** as needed.

Rear entry storm door is damaged. Recommend correction by a **qualified person** as needed.

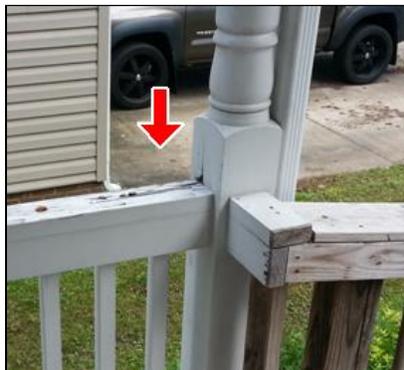
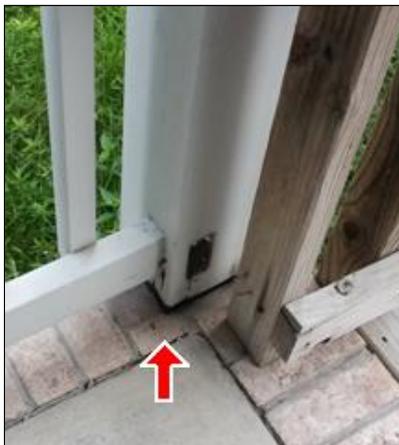
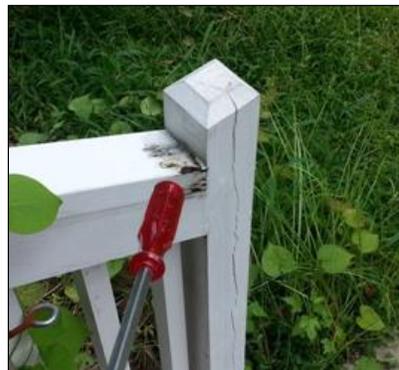
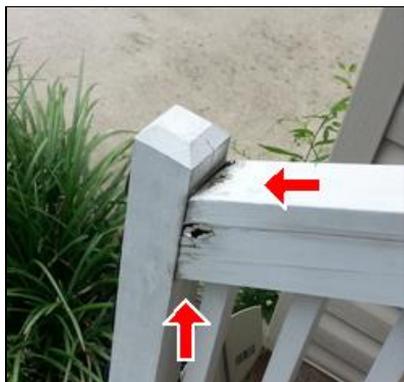
(1) Front porch- One or more wood components on exterior were or appear to be deteriorated, loose, split, warped, damaged, and or substandard in areas. Recommend further evaluation/inspection and correction by a qualified licensed contractor as needed.

(1) Front porch- One or more wood components on exterior were or appear to be deteriorated, loose, split, warped, damaged, and or substandard in areas. Recommend further evaluation/inspection and correction by a qualified licensed contractor as needed.

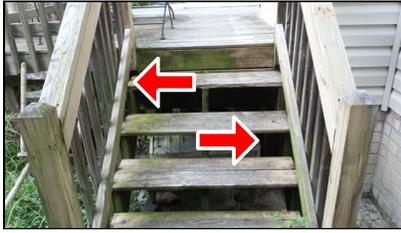
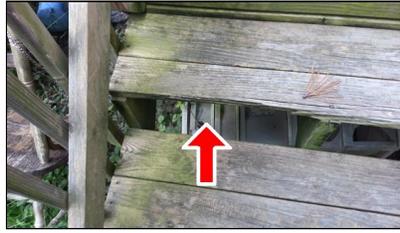
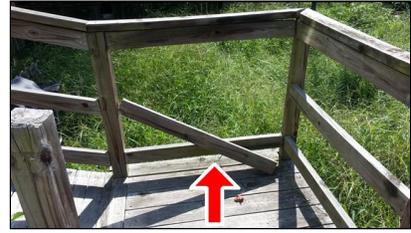
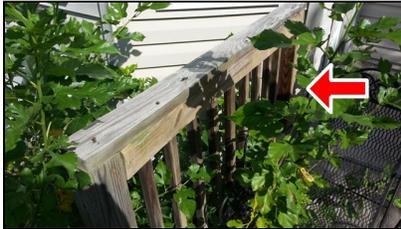
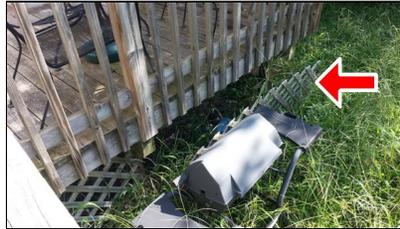
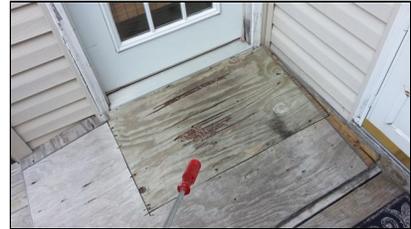
(2) Rear deck, and ramp- One or more wood components on exterior were or appear to be deteriorated, loose, split, warped, damaged, and or substandard in areas. Recommend further evaluation/inspection and correction by a qualified licensed contractor as needed.

(2) Rear deck, and ramp- One or more wood components on exterior were or appear to be deteriorated, loose, split, warped, damaged, and or substandard in areas. Recommend further evaluation/inspection and correction by a qualified licensed contractor as needed.

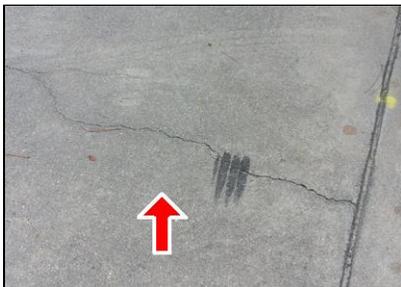
2.5 Item 1(Picture)

(1) The concrete drive/walk and or patio has typical settlement cracks, and or deterioration. Further deterioration can occur if not repaired. A qualified person should repair or replace as needed and or monitor.

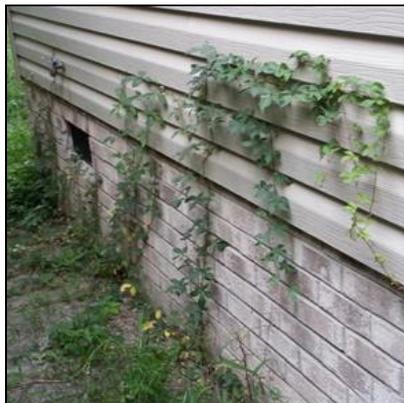
2.5 Item 2(Picture) Left side of home-

(2) Vegetation such as trees, shrubs and/or vines was in contact with or less than one foot from building exteriors. Vegetation can serve as a conduit for wood destroying insects and may retain moisture against the exterior after it rains. Vegetation should be pruned and/or removed as necessary to maintain a one foot clearance between it and building exteriors.

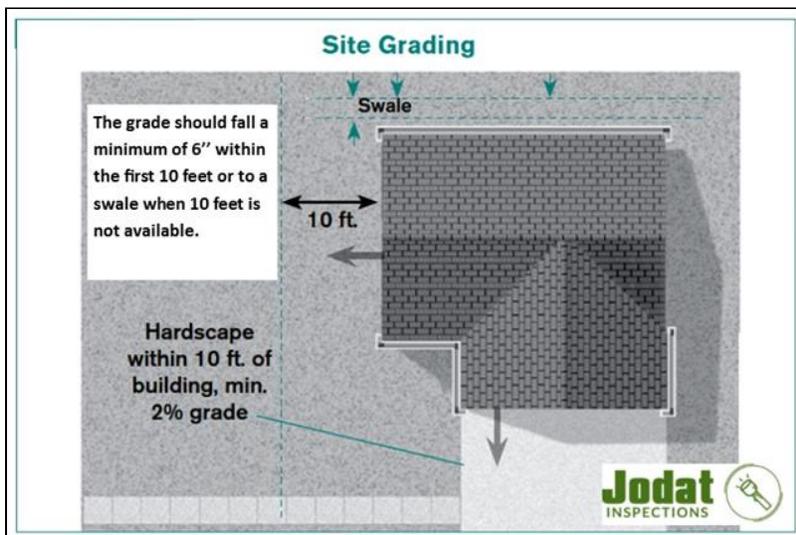
2.5 Item 3(Picture)

(3) **Exterior in areas** -There is a negative/not enough slope towards the home this can cause or contribute to water intrusion or deterioration. I recommend correcting landscape and or hardscape to drain water away from home. The grade should fall from home 6" within the first 6 to 10 feet from home. If grading is not possible I recommend contacting a qualified landscaper/contractor and explore options such as french drains and dry wells.

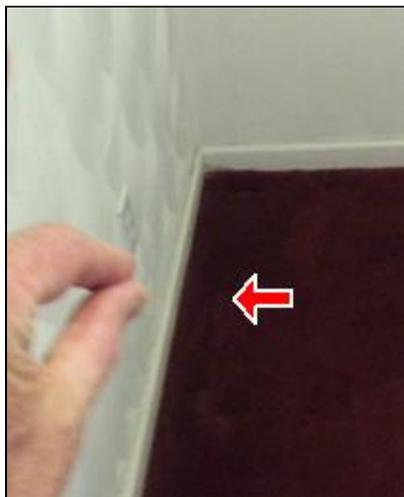
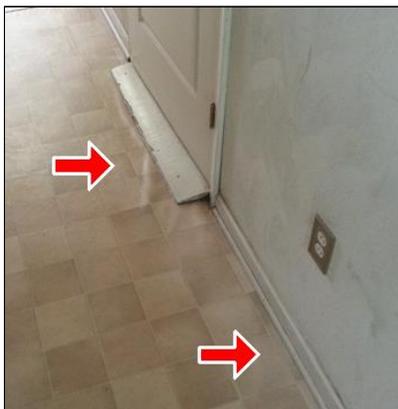
(2) Hallway, and first level right room area- wall area near the bottom tested as having a high moisture content. Water and moisture can or has caused damage to structure members. Recommend further evaluation/ inspection and correction by a qualified licensed contractor as needed.

(2) Hallway, and first level right room area- wall area near the bottom tested as having a high moisture content. Water and moisture can or has caused damage to structure members. Recommend further evaluation/inspection and correction by a qualified licensed contractor as needed.

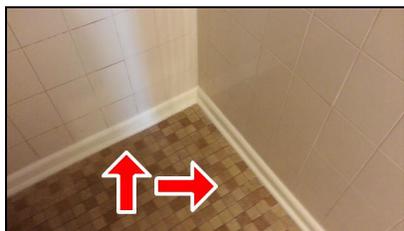
3.2 Item 3(Picture)

(3) First level bathroom shower is constructed in a substandard manner. Wood trim in shower is improper. This area appears to causing moisture issues to structure at surrounding walls and underneath in crawlspace. Recommend further evaluation/inspection and correction by a qualified licensed contractor as needed.

(3) First level bathroom shower is constructed in a substandard manner. Wood trim in shower is improper. This area appears to causing moisture issues to structure at surrounding walls and underneath in crawlspace. Recommend further evaluation/inspection and correction by a qualified licensed contractor as needed.

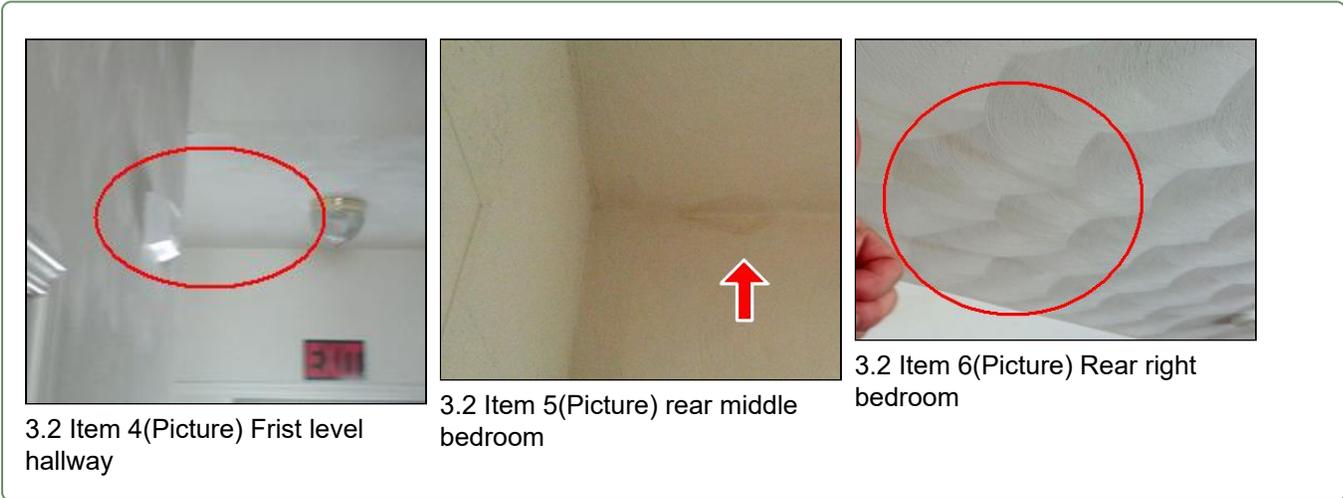
(4) Stains and or Repairs were found in one or more ceiling areas. However, no elevated levels of moisture were found. The stain(s) may be due to past roof and/or plumbing leaks. Consult with the property owner and monitor the stained area(s) in the future, especially after heavy or prolonged rain. If elevated moisture is found in the future, then recommend that a qualified contractor evaluate and repair as necessary.

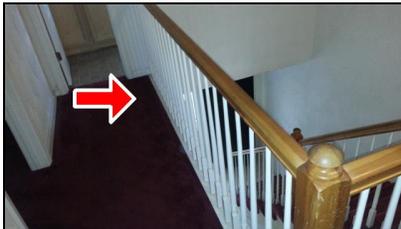
3.3 Item 1(Picture)

Stairs to second level and at second level - The handrail/guard rail inside home are loose. A fall or injury could occur. I recommend a qualified contactor repair or replace as needed.

Stairs to second level and at second level - The handrail/guard rail inside home are loose. A fall or injury could occur. I recommend a qualified contractor repair or replace as needed.

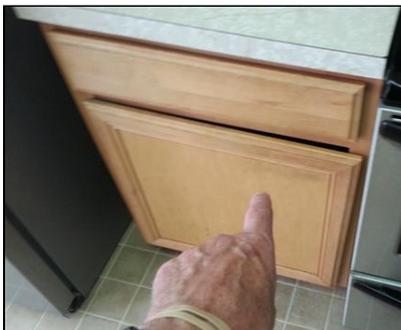
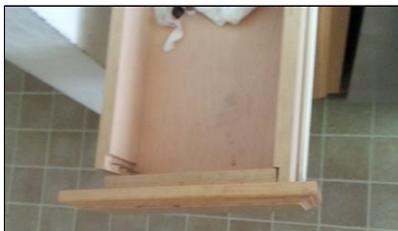
(2) One or more cabinet doors, drawers are damaged and or out of alignment. Recommend further evaluation/ inspection and correction by a qualified licensed contractor as needed.

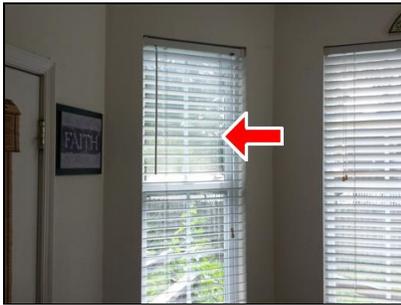
3.5 Item 1(Picture)

(2) **Kitchen-** Condensation or staining was visible between multi-pane glass in one or more windows, doors and or skylights. This **usually indicates that the seal between the panes of glass has failed** or that the desiccant material that absorbs moisture is saturated. As a result, the view through the window may be obscured, the window's R-value will be reduced, and accumulated condensation may leak into the wall structure below. **Recommend that a qualified contractor evaluate and repair all windows as necessary.** Usually, this means replacing the glass in window frames. Be aware that evidence of failed seals or desiccant may be more or less visible depending on the temperature, humidity, sunlight, etc. Windows or glass-paneled doors other than those that the inspector identified may also have failed seals and need glass replaced. **It is beyond the scope of this inspection to identify every window with failed seals or desiccant.**

(2) **Kitchen-** Condensation or staining was visible between multi-pane glass in one or more windows, doors and or skylights. This **usually indicates that the seal between the panes of glass has failed** or that the desiccant material that absorbs moisture is saturated. As a result, the view through the window may be obscured, the window's R-value will be reduced, and accumulated condensation may leak into the wall structure below. **Recommend that a qualified contractor evaluate and repair all windows as necessary.** Usually, this means replacing the glass in window frames. Be aware that evidence of failed seals or desiccant may be more or less visible depending on the temperature, humidity, sunlight, etc. Windows or glass-paneled doors other than those that the inspector identified may also have failed seals and need glass replaced. **It is beyond the scope of this inspection to identify every window with failed seals or desiccant.**

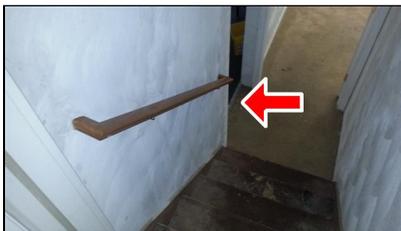
4.7 Item 1(Picture)

Garage- Handrails/guardrails at stairs are loose. This is a potential fall hazard. Recommend that a qualified contractor repair replace as needed.

Garage- Handrails/guardrails at stairs are loose. This is a potential fall hazard. Recommend that a qualified contractor repair replace as needed.

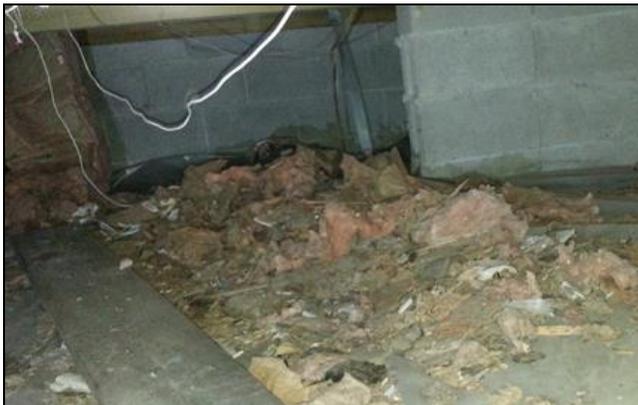
5.0 Item 1(Picture)

(2) Cellulose material such as scrap wood, cardboard, paper, form wood, cardboard forms was found in the crawl space. This is a conducive condition for wood-destroying organisms. Recommend removing all cellulose-based debris or stored items.

(2) Cellulose material such as scrap wood, cardboard, paper, form wood, cardboard forms was found in the crawl space. This is a conducive condition for wood-destroying organisms. Recommend removing all cellulose-based debris or stored items.

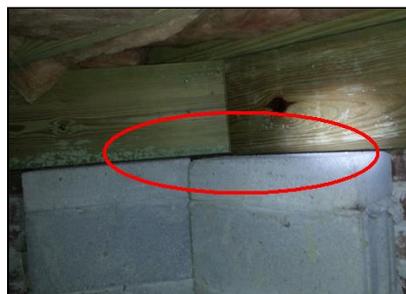
5.3 Item 1(Picture)

(2) Griders/beams at rear of home under kitchen area missing "shims". Floor sagging could occur. Recommend correction by a qualified licensed contractor as needed.

(2) Griders/beams at rear of home under kitchen area missing "shims". Floor sagging could occur. Recommend correction by a qualified licensed contractor as needed.

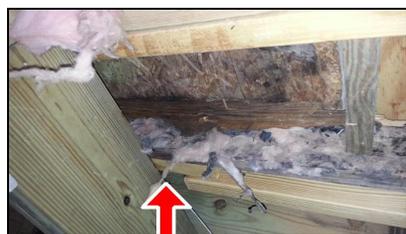
5.3 Item 2(Picture)

(3) Under bathroom in crawlspace- One or more floor joist is deteriorated. Needs replaced or properly sistered. Sistered wood member from pervious repair is improper. Recommend further evaluation/inspection and correction by a qualified licensed contractor as needed.

(3) Under bathroom in crawlspace- One or more floor joist is deteriorated. Needs replaced or properly sistered. Sistered wood member from pervious repair is improper. Recommend further evaluation/inspection and correction by a qualified licensed contractor as needed.

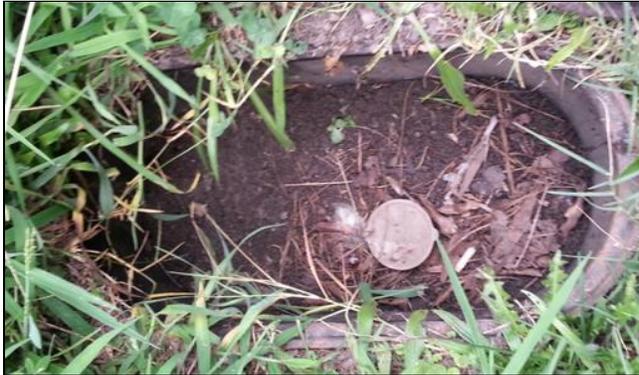
6.0 Item 1(Picture)

The main water shut-off valve was in contact with **soil**. Corrosion or rust can occur as a result. Recommend removing or grading soil, or making modifications as necessary so the valve is not in contact with soil.

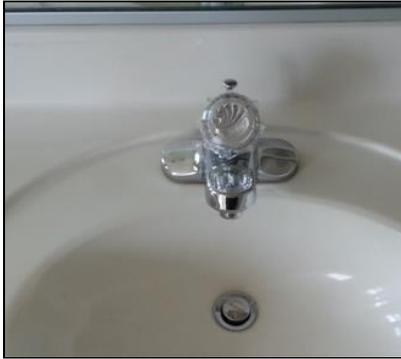
6.2 Item 1(Picture) Master bathroom-

(2) Master bathroom- -The sinks control knob/stopper system is not working properly and or missing components. I recommend a qualified person repair/replace as needed.

(2) Master bathroom- -The sinks control knob/stopper system is not working properly and or missing components. I recommend a qualified person repair/replace as needed.

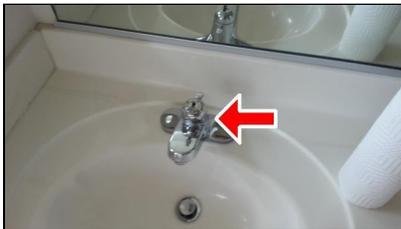
6.2 Item 2(Picture)

(3) Master bathroom- Sink control lever is damaged and or missing components. Recommend further evaluation/inspection and correction by a qualified licensed **plumbing** contractor as needed.

(3) Master bathroom- Sink control lever is damaged and or missing components. Recommend further evaluation/inspection and correction by a qualified licensed **plumbing** contractor as needed.

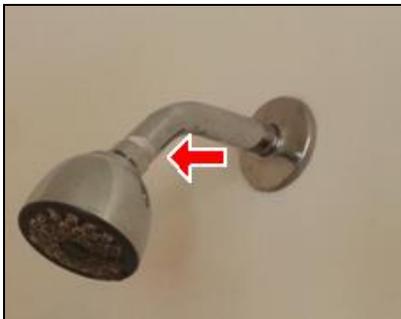
6.2 Item 3(Picture)

(6) **First and second level bathroom** --Shower heads leaks. Recommend correction by a qualified licensed plumbing contractor.

(6) **First and second level bathroom** --Shower heads leaks. Recommend correction by a qualified licensed plumbing contractor.

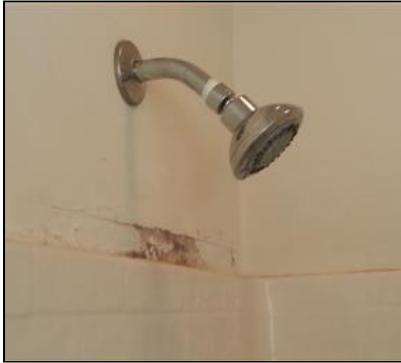
6.2 Item 4(Picture)

(7) Master bath shower leaks while in use and damage observed to wall. Recommend correction by a **qualified person** as needed.

(7) Master bath shower leaks while in use and damage observed to wall. Recommend correction by a **qualified person** as needed.

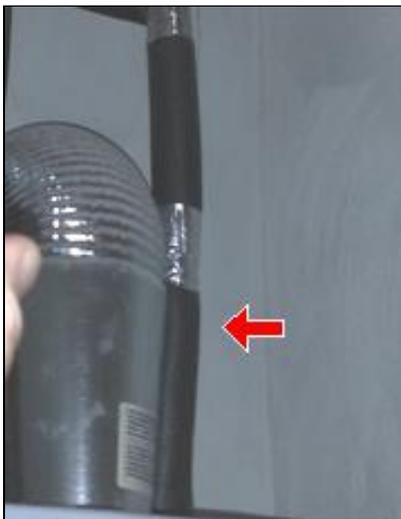
6.3 Item 1(Picture)

(3) The "B" vent pipe for the gas water heater does not have proper clearance to combustibles. One inch required. Safety hazard. Foam insulation needs removed on pipe with 1 inch of vent pipe.

(3) The "B" vent pipe for the gas water heater does not have proper clearance to combustibles. One inch required. Safety hazard. Foam insulation needs removed on pipe with 1 inch of vent pipe.

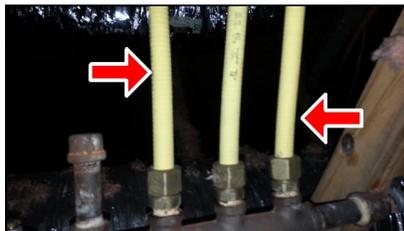
6.5 Item 1(Picture)

All CSST manufacturers expressly added the bonding and grounding procedure to their installation requirements in August 2006. This improved safety installation requirement reduces the likelihood of an electrical surge that can potentially cause a fire.

(2) A common gas piping system called Corrugated Stainless Steel Tubing or CSST is present in this home. A lawsuit in 2005 claimed that CSST poses an unreasonable risk of fire due to lightning strikes. The lawsuit was settled and the manufacturers agreed to require additional electrical bonding above the minimum requirements set by the National Electric Code. In most circumstances, the bonding is required to be connected to the house electrical system. **We could not confirm that such bonding was present.** We recommend a further evaluation and repair as deemed necessary by a competent, licensed electrician familiar with the requirements of this type of gas piping.

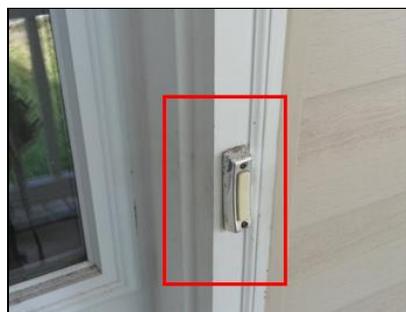
7.3 Item 1(Picture)

(2) **Main entry door--** The door bell did not work when tested Recommend a qualified electrical contractor evaluate and repair/replace as needed.

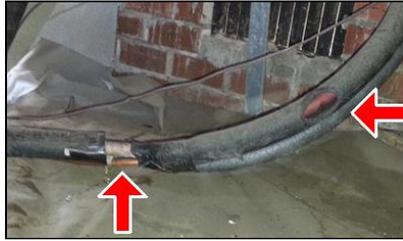
8.4 Item 1(Picture)

(3) Insulation on the heat pump or air conditioning condensing unit's refrigerant lines was deteriorated or missing in one or more areas. This may result in reduced efficiency and increased energy costs, and add unwanted moisture in **crawlspace**. Recommend that a qualified person replace or install insulation as necessary.

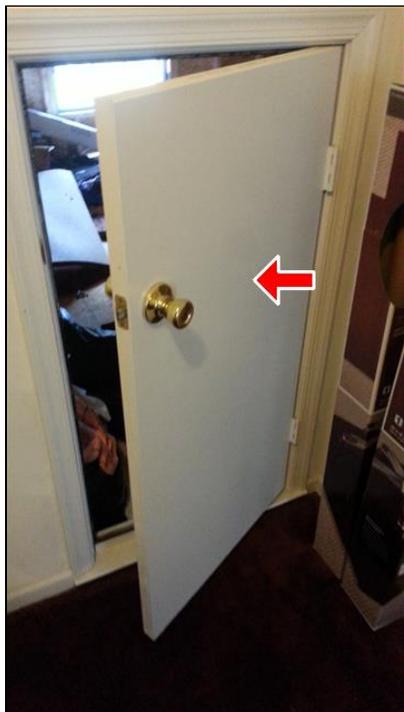
9.0 Item 2(Picture)

(3) Typical for age of home. Upgrade recommendation. -One or more attic access panel(s) and or doors are not insulated. I recommend adding insulation to prevent heat/energy loss. A qualified person should repair as needed.

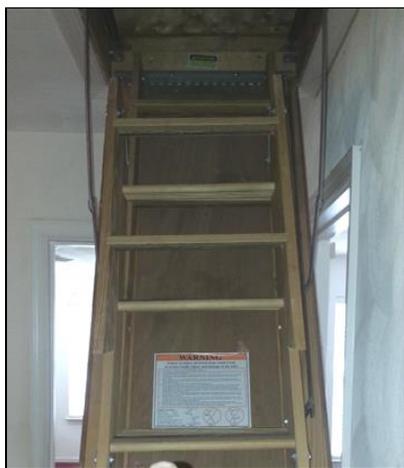
9.0 Item 3(Picture)

(4) Typical for age of home. Upgrade recommendation. The pull down stairs are not insulated. I recommend adding insulation to prevent heat/energy loss. A qualified person should repair as needed.

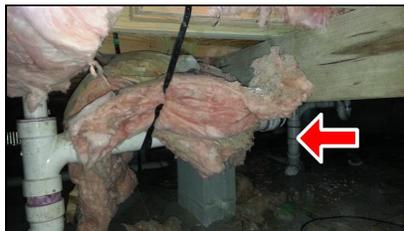
9.1 Item 1(Picture)

The insulation is missing and or is loose/fallen in the crawlspace. Heat loss can occur more on this home than one that is properly insulated. Recommend correction by a qualified licensed contractor.

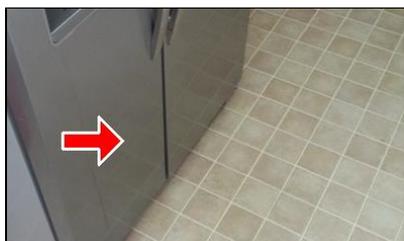
10.6 Item 1(Picture)

(2) The refrigerator did not close properly, appears bent/damaged. Recommend further evaluation/inspection and correction by a qualified licensed contractor as needed.

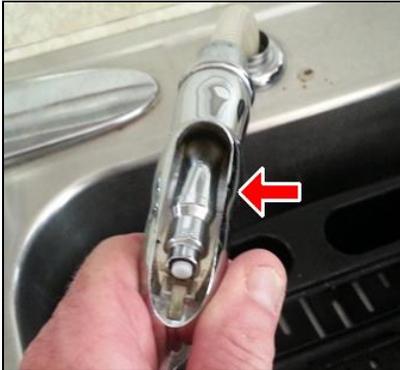
10.7 Item 1(Picture)

The sink sprayer did not work when tested. Has missing and or damaged components. Recommend further evaluation/inspection and correction by a qualified licensed plumbing contractor as needed.

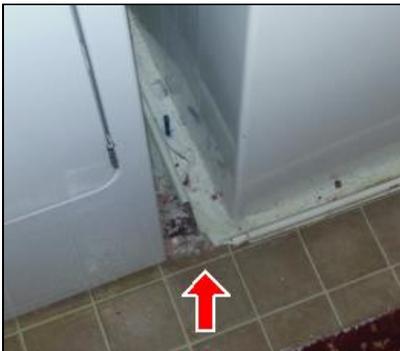
(2) Washing machine drip pan is damaged and the drain connection is loose. Recommend correction by a qualified licensed contractor as desired.

10.8 Item 1(Picture) damaged
