Inspection Report

777 Happy Street
Norfolk VA 23458

JODAT INSPECTIONS

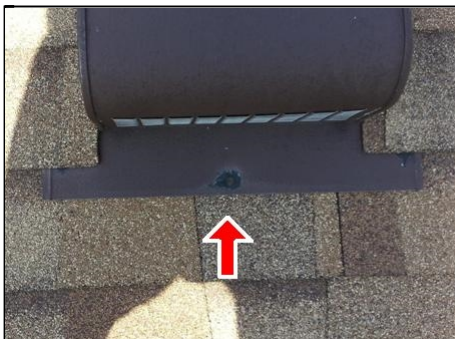
1.2 Item 1(Picture) Rear of home

(1) Nail heads were exposed at one or more roof penetrations. Recommend applying an approved sealant over exposed nail heads now and as necessary in the future to prevent leaks

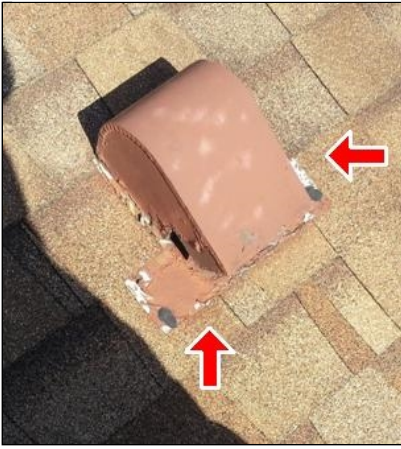
1.2 Item 2(Picture) Rear of home

(2) Caulking was deteriorating exposed at one or more roof penetrations. Recommend applying an approved sealant over now and as necessary in the future to prevent leaks.

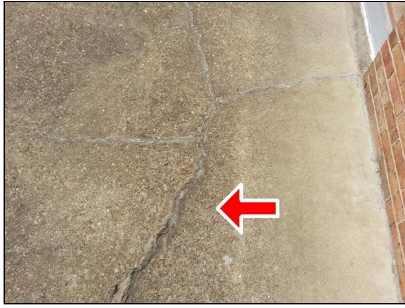
2.5 Item 1(Picture)

The concrete slab at the rear of home has dropped or settled causing a steep or uneven step. Further deterioration can occur if not repaired. A qualified person should repair or replace as needed.

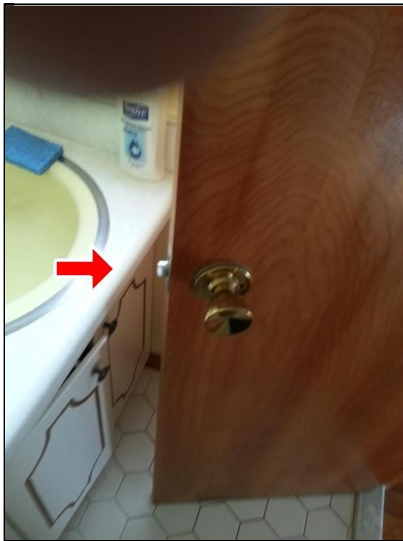
3.1 Item 1(Picture)

The bath room and closet doors needs adjustment they do not latch properly in the Master Bedroom. This is a small repair. A qualified person should repair or replace as needed.

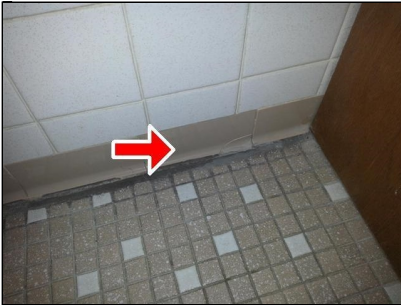
3.3 Item 2(Picture)

(2) Tile is damaged at the hall bath. This is a small repair issue for your information. A qualified person should repair or replace as needed.

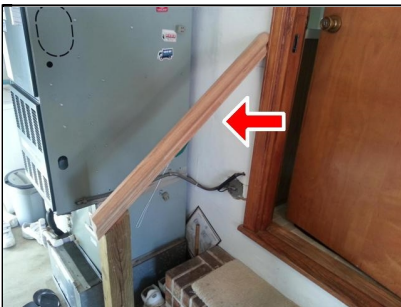
3.5 Item 1(Picture)

The hand/guard rail for the steps in garage are loose. A fall or injury could occur if not corrected. I recommend repair as needed.

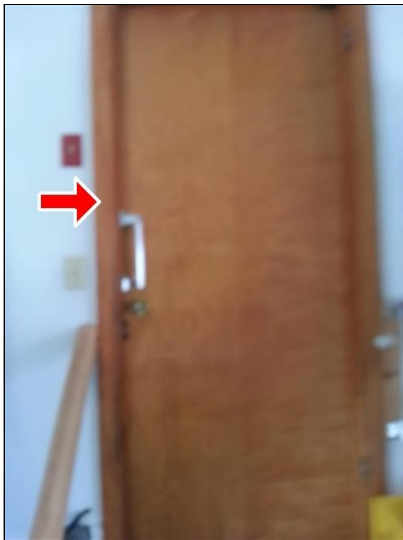
4.4 Item 1(Picture)

The occupant door from inside garage to inside the home is not a fire rated door. This means that should a fire occur in garage, the occupant door does not afford protection until fireman arrive. This door should be replaced with a fire rated door.

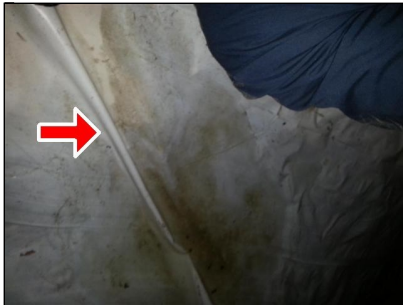
5.0 Item 1(Picture)

(1) Visible signs of water intrusion in the crawlspace are present from standing water in at least two locations. I am unable to determine the extent of intrusion or how often it occurs. It is recommend to monitor and repair as needed.

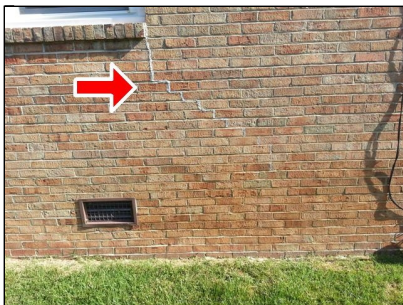
5.0 Item 2(Picture)

(2) The stair-step crack(s) in the Brick Veneer wall at the right side (facing front). These cracks do not appear significant to require repairs at this time. A qualified licensed general contractor should inspect further and repair as needed.

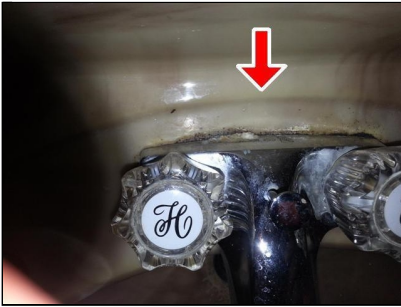
6.2 Item 1(Picture)

The sink faucets caulking in the at the hall bath is failing. Repairs are needed to stop leaking water from damaging the cabinet bottom or to eliminate moisture that may contribute to fungi growth. A qualified person should repair as necessary.

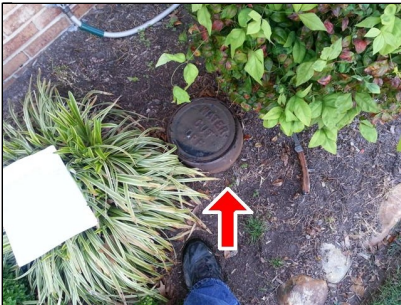
6.4 Item 1(Picture)

Main water cutoff is in front right of house as you are facing the house. City water meter is at the street.

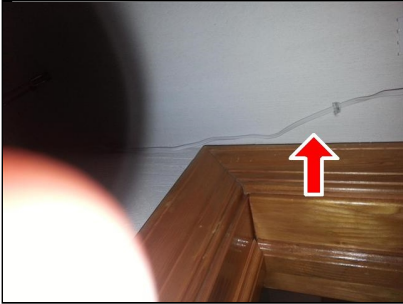
7.3 Item 2(Picture)

(2) In the right rear bedroom facing the home. Extension cord used as permanent wiring at the light fixture in the closet. Electrical issues are considered a hazard until repaired. I recommend repair as needed A qualified licensed electrical contractor should perform repairs that involve wiring.

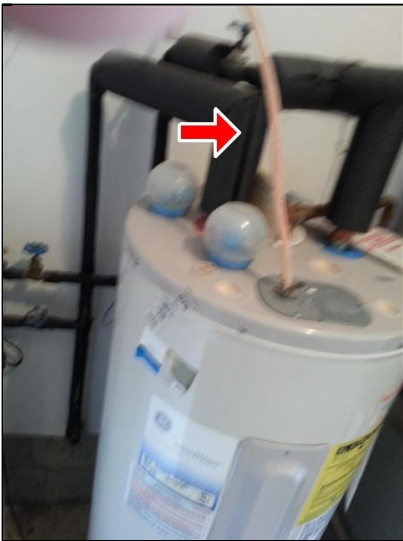
7.3 Item 3(Picture)

(3) The wiring for the water heater missing romex covering ie metal jacket. Electrical issues are considered a hazard until repaired. I recommend a licensed electrical contractor correct as necessary.

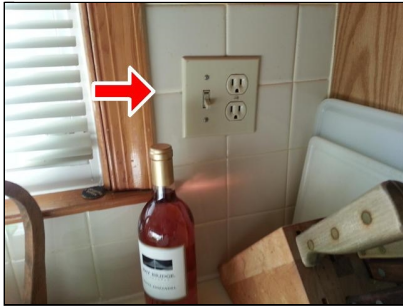
7.4 Item 1(Picture)

One or more electric receptacles (outlets) at the kitchen, bathroom(s), garage, exterior, had no visible ground fault circuit interrupter (GFCI) protection, or the inspector was unable to determine if GFCI protection was present. If not GFCI-protected, receptacles in wet areas pose a shock hazard. Recommend that a qualified electrician evaluate and install GFCI protection if necessary and per standard building practices. General guidelines for GFCI-protected receptacles include the following locations: Outdoors (since 1973) Bathrooms (since 1975) Garages (since 1978) Kitchens (since 1987) Crawl spaces and unfinished basements (since 1990) Wet bar sinks (since 1993) Laundry and utility sinks (since 2005)

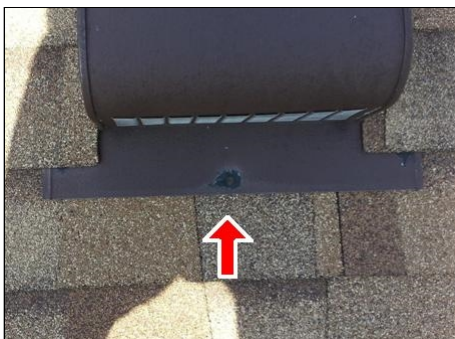
1.2 Item 1(Picture) Rear of home

(1) Nail heads were exposed at one or more roof penetrations. Recommend applying an approved sealant over exposed nail heads now and as necessary in the future to prevent leaks

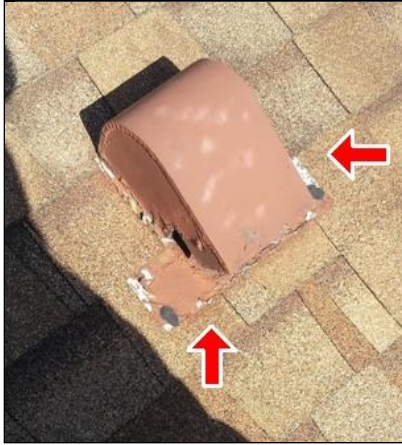
1.2 Item 2(Picture) Rear of home

(2) Caulking was deteriorating exposed at one or more roof penetrations. Recommend applying an approved sealant over now and as necessary in the future to prevent leaks.

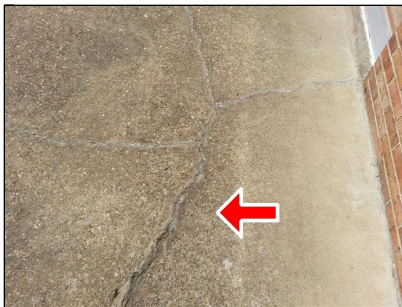
2.5 Item 1(Picture)

The concrete slab at the rear of home has dropped or settled causing a steep or uneven step. Further deterioration can occur if not repaired. A qualified person should repair or replace as needed.

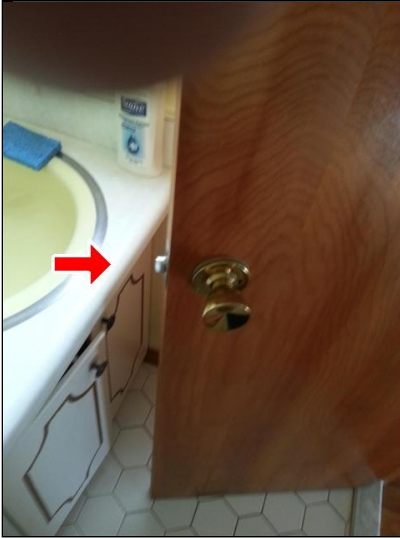
3.1 Item 1(Picture)

The bath room and closet doors needs adjustment they do not latch properly in the Master Bedroom. This is a small repair. A qualified person should repair or replace as needed.

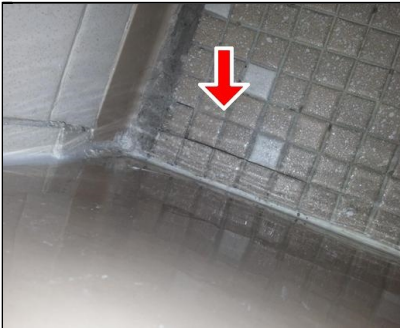
3.3 Item 1(Picture)

(1) Tile missing grout at the hall bath. This is a small repair issue for your information. A qualified person should repair or replace as needed.

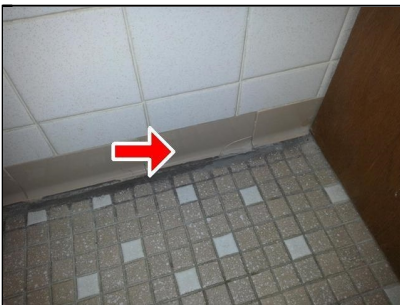
3.3 Item 2(Picture)

(2) Tile is damaged at the hall bath. This is a small repair issue for your information. A qualified person should repair or replace as needed.

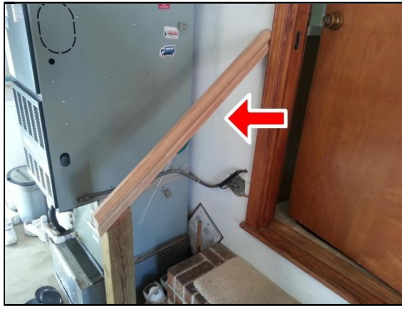
3.5 Item 1(Picture)

The hand/guard rail for the steps in garage are loose. A fall or injury could occur if not corrected. I recommend repair as needed.

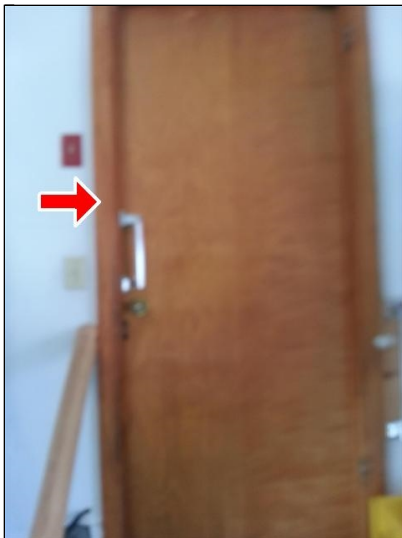
4.4 Item 1(Picture)

The occupant door from inside garage to inside the home is not a fire rated door. This means that should a fire occur in garage, the occupant door does not afford protection until fireman arrive. This door should be replaced with a fire rated door.

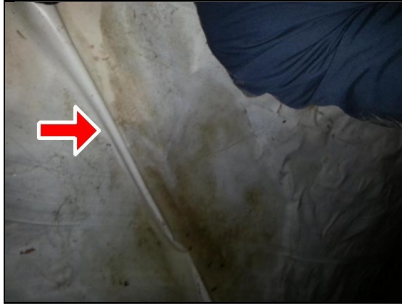
5.0 Item 1(Picture)

(1) Visible signs of water intrusion in the crawlspace are present from standing water in at least two locations. I am unable to determine the extent of intrusion or how often it occurs. It is recommend to monitor and repair as needed.

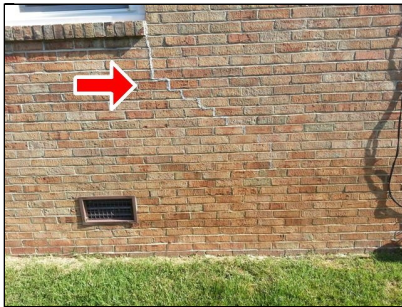
5.0 Item 2(Picture)

(2) The stair-step crack(s) in the Brick Veneer wall at the right side (facing front). These cracks do not appear significant to require repairs at this time. A qualified licensed general contractor should inspect further and repair as needed.

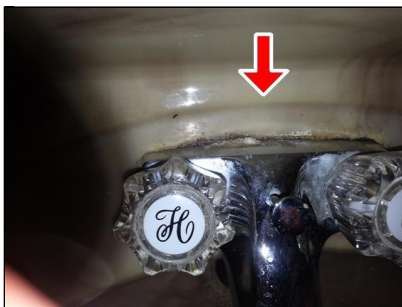
6.2 Item 1(Picture)

The sink faucets caulking in the at the hall bath is failing. Repairs are needed to stop leaking water from damaging the cabinet bottom or to eliminate moisture that may contribute to fungi growth. A qualified person should repair as necessary.

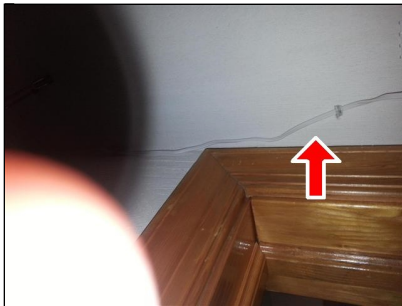
7.3 Item 2(Picture)

(2) In the right rear bedroom facing the home. Extension cord used as permanent wiring at the light fixture in the closet. Electrical issues are considered a hazard until repaired. I recommend repair as needed A qualified licensed electrical contractor should perform repairs that involve wiring.

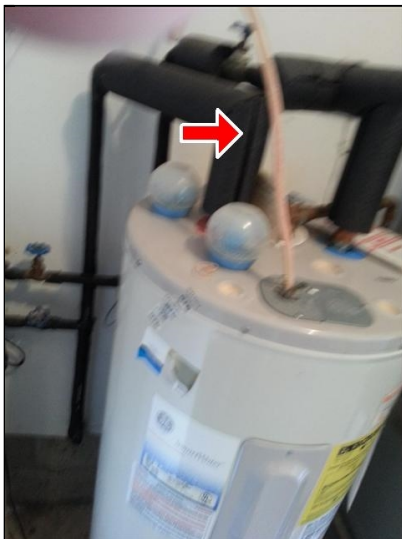
7.3 Item 3(Picture)

(3) The wiring for the water heater missing romex covering ie metal jacket. Electrical issues are considered a hazard until repaired. I recommend a licensed electrical contractor correct as necessary.

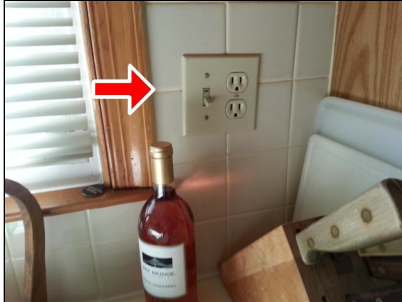
7.4 Item 1(Picture)

One or more electric receptacles (outlets) at the kitchen, bathroom(s), garage, exterior, had no visible ground fault circuit interrupter (GFCI) protection, or the inspector was unable to determine if GFCI protection was present. If not GFCI-protected, receptacles in wet areas pose a shock hazard. Recommend that a qualified electrician evaluate and install GFCI protection if necessary and per standard building practices. General guidelines for GFCI-protected receptacles include the following locations: Outdoors (since 1973) Bathrooms (since 1975) Garages (since 1978) Kitchens (since 1987) Crawl spaces and unfinished basements (since 1990) Wet bar sinks (since 1993) Laundry and utility sinks (since 2005)
