Inspection Report

Happy Client

Property Address:
1234 Somewhere Street
Hampton Roads Area Virginia 12345

JODAT INSPECTIONS

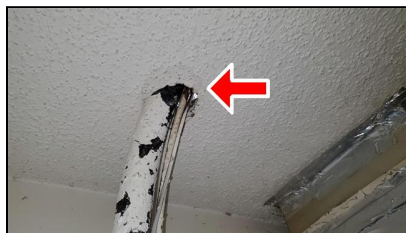
(1) Stains, imperfections and or Repairs were observed in one or more wall, floor, ceiling, windows, other interior components and or associated areas. However, no elevated levels of moisture were found (*unless noted in report*). The stain(s)/ imperfection(s) may be due to past roof, building, window, HVAC and/or plumbing leaks, and/or other issues for example. Consult with the property owner and monitor area(s) in the future for example after heavy or prolonged rain. If elevated moisture or issues are found in the future, then recommend that a qualified specialist contractor evaluate and repair as necessary. Pictures are examples only. Pictures are examples only.

1.0 Item 1(Picture) Example/
Sample- closet area where HVAC
air handler located

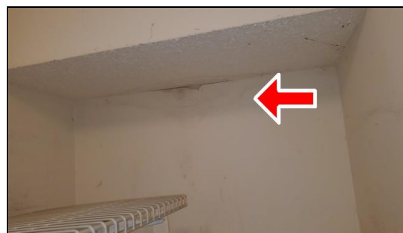
1.0 Item 2(Picture) Example/
Sample- washer dryer area

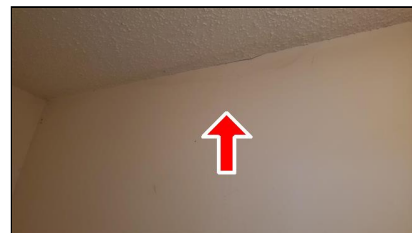
1.0 Item 3(Picture) Example/
Sample- washer dryer area

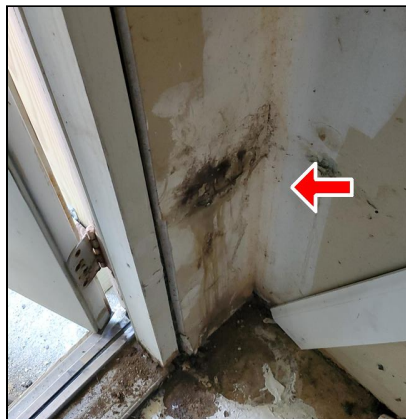
1.0 Item 4(Picture) Example/
Sample- shed

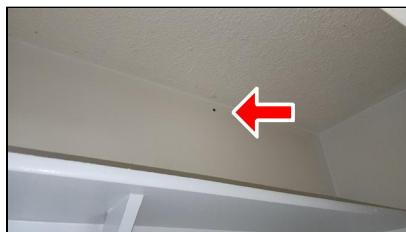
(2) Minor cracks, nail pops, cracks, damage and/or blemishes were found in walls, floors, doors, windows, ceilings, counter tops, fixtures, and or cabinets in one or more areas. Cracks and nail pops are common, are often caused by lumber shrinkage or minor settlement, and can be more or less noticeable depending on changes in humidity. They did not appear to be a structural concern (unless noted in report). However: Recommend monitoring all cracks and if worsen over time have evaluated and repaired by qualified contractor as needed. But the client may wish to repair these for aesthetic reasons. **FYI** – *we do not put example pictures of minor cracks, nail pops, blemishes, items considered cosmetic etc. in the report if examples are included they are to be considered examples only and not inclusive.*

1.0 Item 5(Picture) Example/
Sample- Primary Bedroom Closet

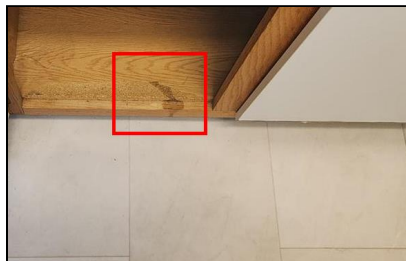
(5) **FYI-** Leaks and or spills have occurred under one or more sinks. Cabinets appear functional at this time (unless noted in report). Recommend monitor. Pictures are examples only.

1.0 Item 6(Picture) Example/
Sample- Kitchen Sink

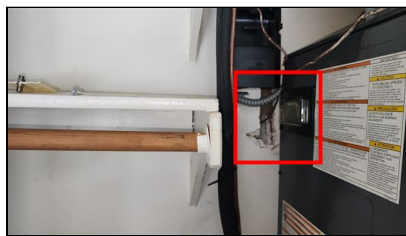
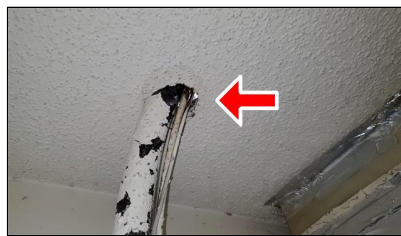
(7) Openings/gaps observed in one or more areas. Insects, rodents and or pest could enter. Recommend all openings/gaps be sealed properly. **FYI-** *A rat can fit in openings as small as a Quarter, and mice as small as a dime.* Pictures are examples only.

1.0 Item 7(Picture) Example/
Sample- Front Right Bedroom
Closet

1.0 Item 8(Picture) Example/
Sample- Front Right Bedroom
Closet

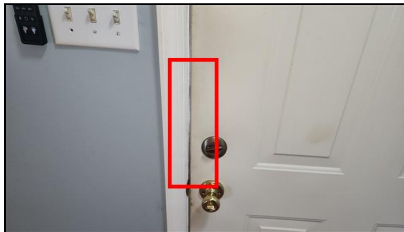
1.2 Item 1(Picture) Example/ Sample- Front Door- Exterior door(s) – weather-stripping- missing

Recommend a qualified contractor correct doors as needed and, ensure doors are functioning properly. Do not rely on pictures alone. Pictures are examples only.

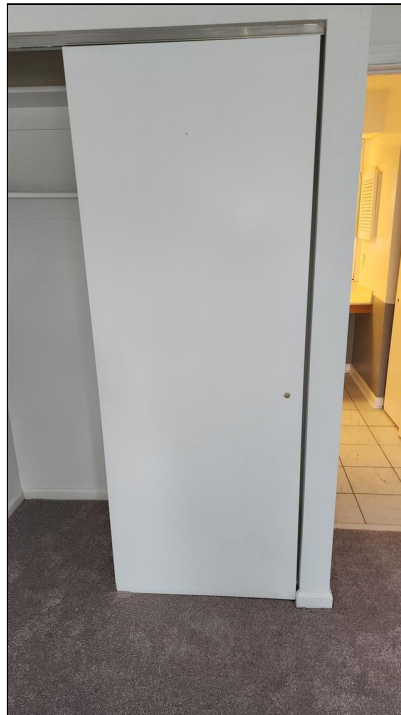
1.2 Item 2(Picture) Example/ Sample- Primary Bedroom Closet- Closet door does not open properly, rubs floor, and/or not in track

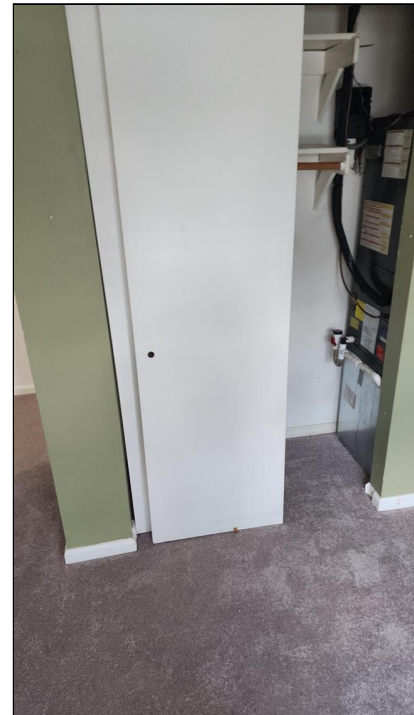
1.2 Item 3(Picture) Example/ Sample- Front Right Bedroom Closet- Closet door does not open properly, rubs floor, and/or not in track

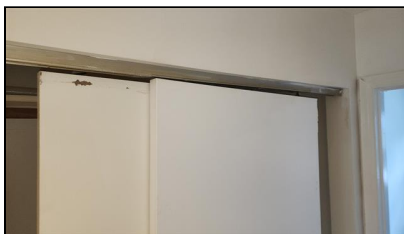
1.2 Item 4(Picture) Example/ Sample- Primary Bathroom Closet- Closet door does not open properly, rubs floor, and/or not in track

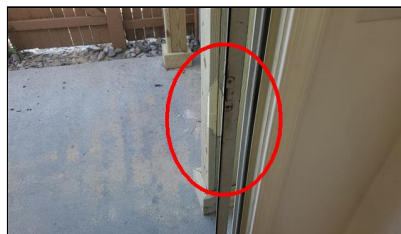
1.2 Item 5(Picture) Example/ Sample-screen door to patio missing handle and the screen is damaged

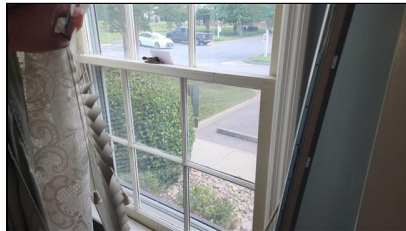
- (2) Window(s) -From a representative amount inspected “problems, concerns and or deficiencies such as-
- Stuck shut and or difficult to operate (This can happen with windows that are older or that have been closed for extended amount of time) Example/Sample- Living Room, Primary Bedroom.

1.5 Item 1(Picture) Example/
Sample- Living Room

and any other problems that a qualified specialist contractor may discover while evaluating further needs correcting to ensure window systems are proper. Window deficiencies can cause moisture/water entry which can cause a host of un-wanted issues. Windows are a egress point in case of emergency such as a fire. Do not rely on pictures alone. Pictures are examples only.

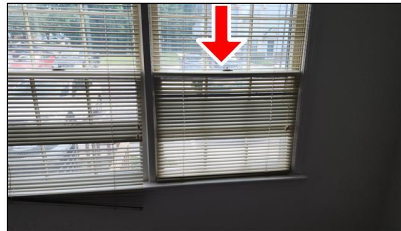
1.5 Item 2(Picture) Example/
Sample- Primary Bedroom

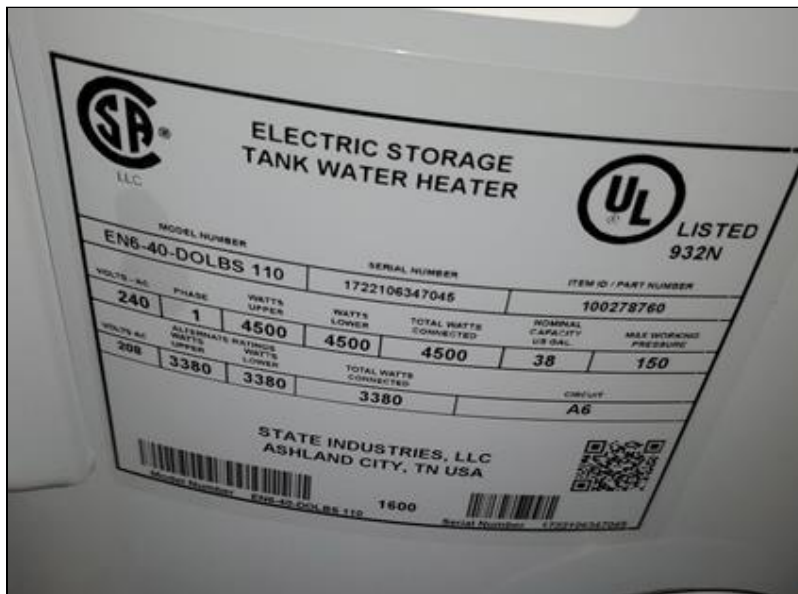
Water heater label

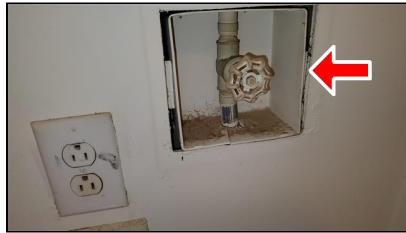
I could not locate the main exterior shut-off for water. Typical finding for condominium style home. Recommend consulting with current owner/builder about all water cutoff locations, and label as needed. Interior cut off located in the washer dryer area.

2.2 Item 1(Picture) . Interior cut off located in the washer dryer area.

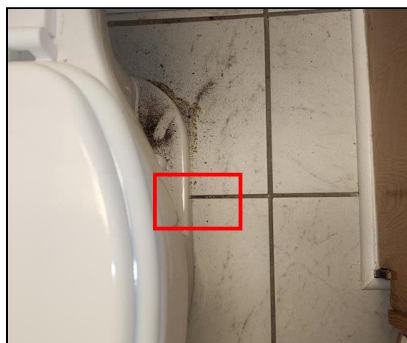
2.3 Item 1(Picture) Example/
Sample- Primary Bathroom- toilet
leaks at floor

and any other problems that a qualified licensed plumbing contractor may discover while performing repairs and inspecting further needs correcting. Additionally check for damage to floor/structure, and correct as needed.

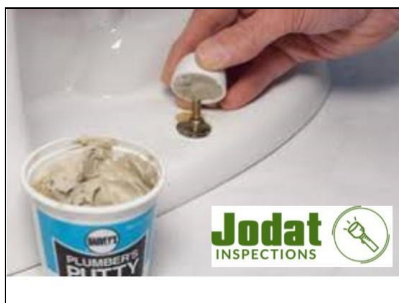
2.3 Item 2(Picture)

(2) Throughout the home there was a sewer smell when the plumbing was being tested, this could be due to long periods of water not being in use that the trap seal in the drain line has dried out allowing sewer smells to escape into the home. Possible health concerns may exist. Recommend further evaluation/inspection and correction by a qualified licensed Plumbing contractor as needed.

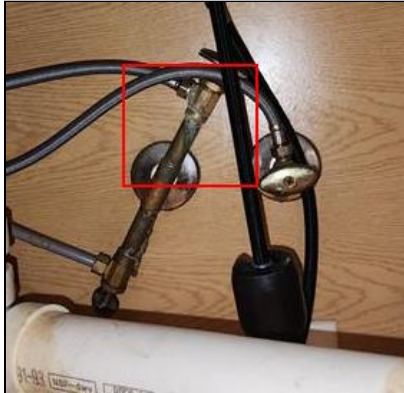
(1) In one or more areas corrosion/deterioration observed on one or more plumbing components no leaks observed at visible areas by the inspector(s) unless noted in the report. Corrosion/deterioration can lead to plumbing issues. Recommend consult current owner for any information regarding any past leaks, and either monitor and/or have a technically exhaustive evaluation of the plumbing system done by a qualified licensed plumbing contractor and make any recommended corrections and/or upgrades. Do not rely on pictures alone when requesting repairs and/or further investigations pictures are examples only.

2.4 Item 1(Picture) Example/
Sample- Kitchen Sink

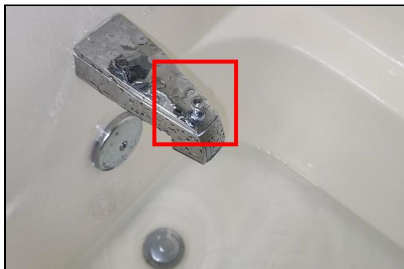
2.4 Item 2(Picture) Example/
Sample- Hall Bathroom Shower-
diverter leaks while engaged, has
to be held in position for shower
mode

and any other problems that a qualified licensed plumbing and/or specialty contractor may discover while evaluating further and performing repairs need correcting. Loose pipes and or components can or have caused leaks. Do not rely on pictures alone. Pictures are examples only.

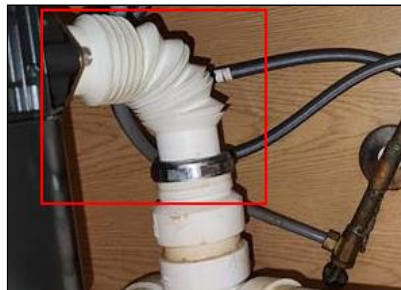
2.4 Item 3(Picture) Example/
Sample- Kitchen- corrugated
drain line

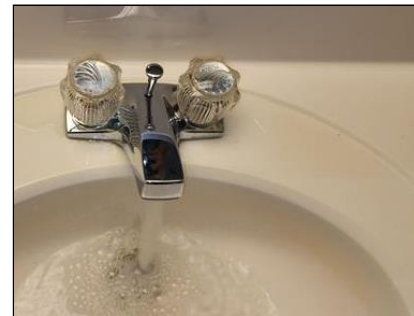
2.4 Item 4(Picture) Example/
Sample- Primary Bathroom Sink-
faucet leaks while in use

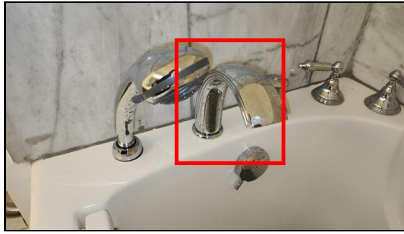
2.4 Item 5(Picture) Example/
Sample- Primary Bathroom Tub-
faucet loose

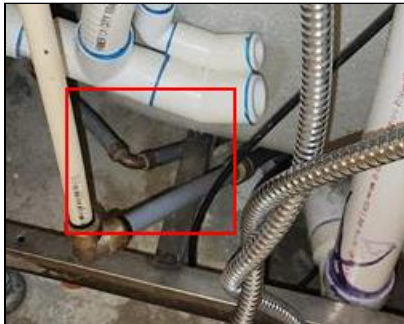
2.4 Item 6(Picture) Example/
Sample-

(3) Polybutylene plumbing pipe (*common polybutylene brand name in our area used – Quest*) water supply pipe(s) observed in one or more areas – Polybutylene plumbing pipe has been involved in several major class action settlements prior to 1989.

(4) **Furthermore for your information** – Polybutylene plastic (PB). This system of plumbing has experienced a higher than normal failure rate associated with leaks where the pipes are joined together. There is also a current theory that chemicals in municipal water systems react with the piping and resins in the fittings, weakening the pipes and joints. The manufacturers have been involved with and settled class action lawsuits alleging manufacturing defects with this plumbing system containing plastic or metal insert fittings (including copper and brass). For further details about PB the web: or <http://www.polybutylene.com> Recommend you research further this type of plumbing system and rely on the evaluation and advice of a licensed plumbing contractor prior to the close of escrow.

I recommend you consult with a licensed plumber and make a informed decision on the PB plumbing pipe at this time. Some home warranty and insurance companies may exclude PB leaks from coverage and or not offer insurance coverage. Listed below is a link that has some useful information. <http://sterlinginspections.com/Polybutylene.html>

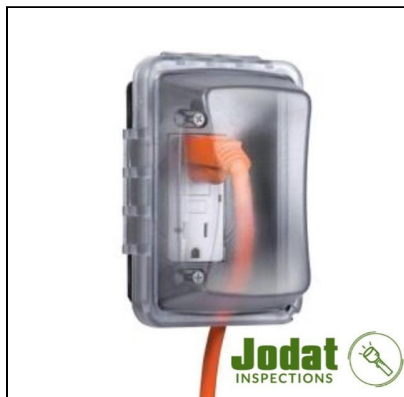
3.0 Item 1(Picture)

(2) *Typical for assumed age of structure- Electrical Safety upgrade recommendation-* All electrical work should be performed by a qualified electrical contractor for safety reasons.

- One or more exterior outlets are intended for "damp areas". Recommend upgrading exterior outlets to outlets intended for "wet areas".
- One or more interior outlets are not tamper resistant receptacles will reduce the likelihood of accidental injury." If a house does not have temper resistant receptacles, it does not make the house unsafe. Installing them makes the house slightly safer.

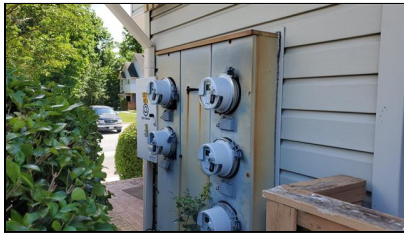
3.3 Item 1(Picture)

(1) The main electrical disconnect located at the right side of the building is not labeled. Recommend labeling as needed this can be a safety concern.

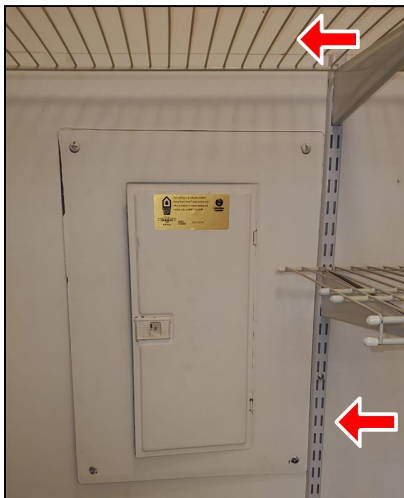
(2) The problems/concerns discovered in one or more electrical panels and or electric system such as -

3.3 Item 2(Picture) – consider removing some of the wire rack system considered a typical finding and rarely corrected

and any other problems that a qualified electrical contractor may discover while inspecting further and performing repairs need correcting a (*this inspection is not a technically exhaustive inspection other deficiencies and/or concerns may exist*). Electrical issues are considered a safety hazard until repaired.

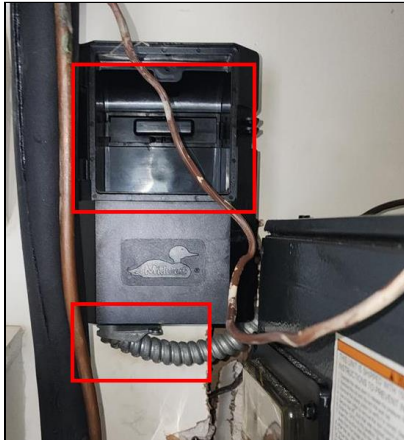
3.4 Item 1(Picture)

Front Right Bedroom Closet -Electrical -problems, concerns and or deficiencies such as one or more -

- HVAC disconnect missing cover
- NM cover damaged/missing components

and any other problems that a qualified electrical contractor may discover while inspecting further and performing repairs need correcting. Electrical issues are considered safety hazards till repaired.

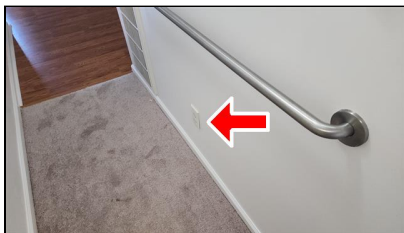
3.5 Item 1(Picture) Example/ Sample- Hallway- Loose outlet

Recommend a qualified licensed Electrical contractor ensure electrical components are in proper and safe working order. Electrical issues are considered safety hazards till repaired. Do not rely on pictures alone when requesting repairs and/or further investigations pictures are examples only.=

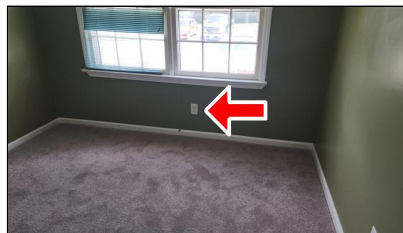
3.5 Item 2(Picture) Example/ Sample- Front Right Bedroom- Loose outlet

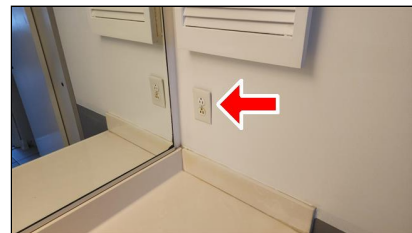
3.5 Item 3(Picture) Example/ Sample- Primary Bathroom- Loose outlet

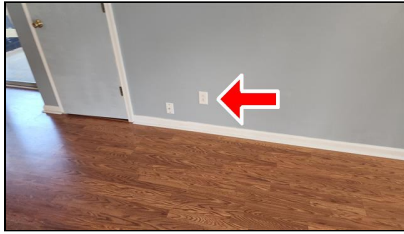
3.5 Item 4(Picture) Example/
Sample- Living Room- Ground
connection missing

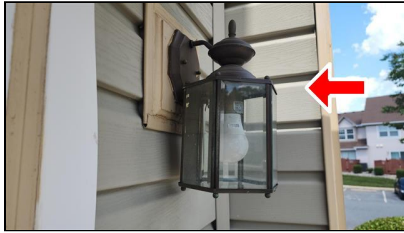
One or more light fixtures were inoperable/not working properly (didn't turn on when nearby switches were operated, flickered, and or missing bulbs for example). Recommend further evaluation by replacing bulbs and/or consulting with the property owner concerning sensors/switch(es) for example. If replacing bulbs doesn't work and/or no other switch(es) can be found, then recommend that a qualified electrician evaluate and repair or replace light fixtures as necessary. Example/Sample- Front Of Home.

3.6 Item 1(Picture) Example/
Sample- Front Of Home

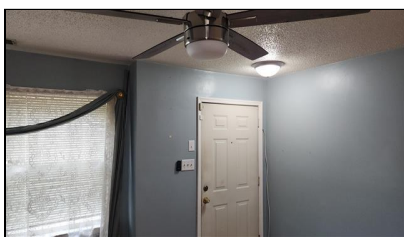
3.7 Item 1(Picture)

- Light turned on however the remote control did not operate when tested. The ceiling fan did not operate in fan mode when tested

and any other problems that a qualified licensed electrical contractor may discover while inspecting fans/ fixtures further and performing repairs need correcting.

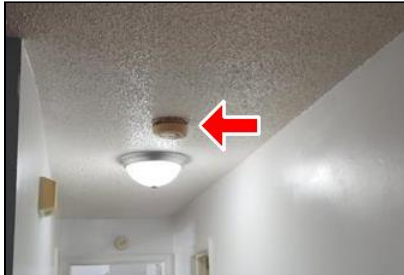
- Smoke alarms damaged and/or appear to be aged. Location(s) – Hallway
- smoke alarms missing and or not observed. Location(s) – Bedrooms
- **FYI** - We also do not smoke-test alarms, which is the only definitive test to confirm proper function. We do not determine the age of smoke alarms. According to the U.S. Fire Administration, most smoke alarms have a life span of 8-10 years.

3.10 Item 1(Picture) Example/
Sample- aged

Inspector recommends a qualified smoke alarm specialist contractor fully evaluate (*technically exhaustive inspection*) of the smoke alarm system(s) and correct as needed to ensure proper function. Possible safety concerns exist. Do not rely on pictures alone. Pictures are examples

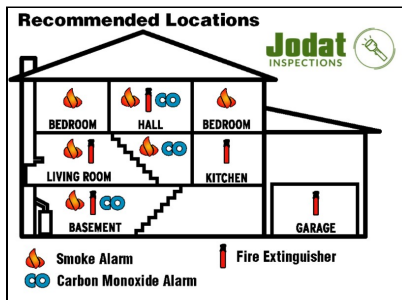
3.11 Item 1(Picture)

Carbon Monoxide alarms, and or Fire Extinguishers missing in areas, incorrect placement and or appear aged. HIGHLY Recommend correction for safety. Inspector recommends to replace all with new (*always follow manufacture instructions for placement*) or have a professional qualified licensed company to ensure proper function and placement. FYI- We do not test Carbon monoxide alarms technical equipment such as Gas analysers are used which is beyond the scope of this inspection. Additionally alarms may be connected to alarms systems/monitoring services in some structures which in turn notify the fire department. Carbon monoxide detectors generally last between five and seven years. The recommendation is to replace them every five years because their ability to detect carbon monoxide is questionable after that point.

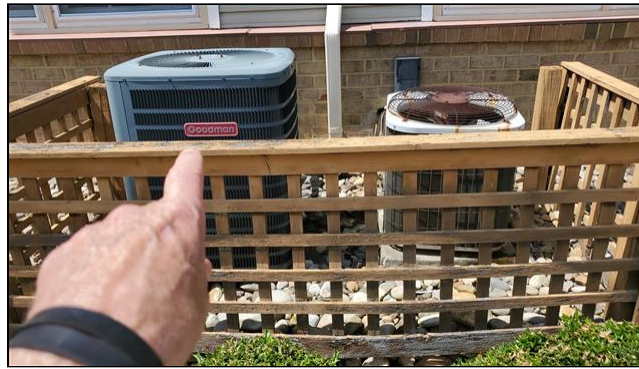
Outside HVAC condenser location

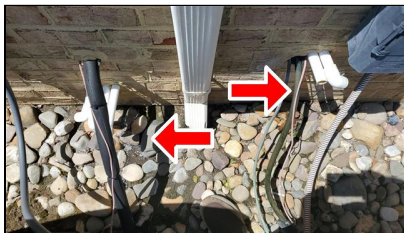
- Appears to be a condensation drain line however inspector could not confirm due to not testing the AC system or due to the outside temperature/humidity –
- Appears to be the responsibility of the condominium Association – needs an extension to carry water away from the structure(s) to a visible area *(3 to 4 feet from foundation sloped as to flow water away from foundation is recommended. Condensate water over time can soften footings and can lead to structural settlement for example)*

4.5 Item 1(Picture) Located at the front of the condominium building

A qualified HVAC contractor should ensure condensate line(s) perform properly and drain away from foundation to a viewable location for the HVAC system(s), and ensure proper function. Pictures are examples only.

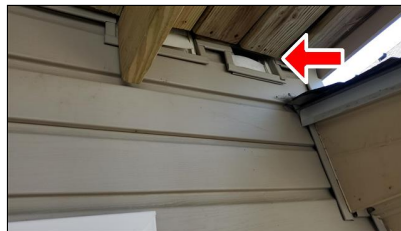
5.3 Item 3(Picture) Located at the right side of home

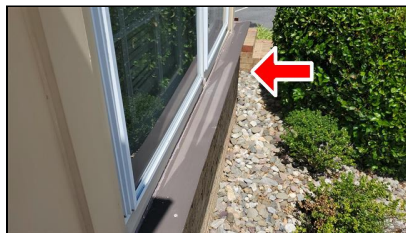
8.0 Item 1(Picture) Example/
Sample- Front of home- Sill slope improper

and any other problems that a qualified specialist contractor may discover while inspecting further and performing repairs need correcting to ensure exterior components are proper and functioning as intended. Moisture/water/pest can enter behind deficiencies which can cause issues. Do not rely on pictures alone. Pictures are examples only. *FYI – we generally do not put examples of caulking, paint and/or weatherstripping deficiencies in the report.*

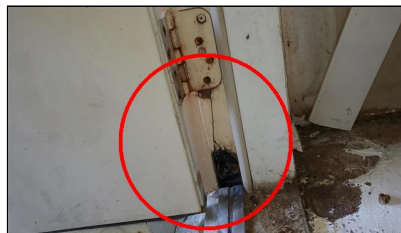
8.0 Item 2(Picture) Example/
Sample- shed trim/framing component damaged
